# Manhole Inspection Summary

Manhole # S43GG\_018MH

Insp Date: **7/6/09 2:08 PM**

**Location** Address: **REAR OF 1229 BROADWAY AVE** Cross Street: **REGISTER ST**

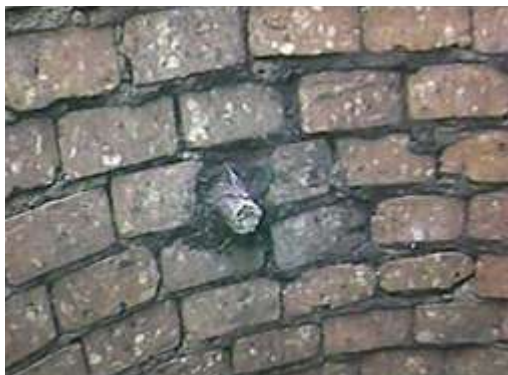
Comments **POSSIBLE ILLICIT CONNECTION - SEE PHOTO CONNECTION @ 3 O'CLOCK IS OUTGOING**

POSSIBLE ILLICIT CONNECTION

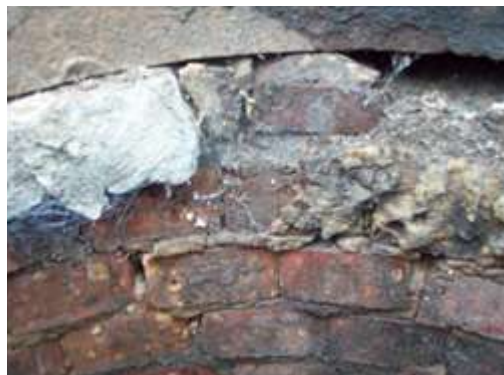
Defect 1

Condition: ☐ Sound ☒ **Cracked** ☐ Root Intrusion ☒ **Loose Brick** ☐ Deteriorated

Cracked chimney and loose bricks

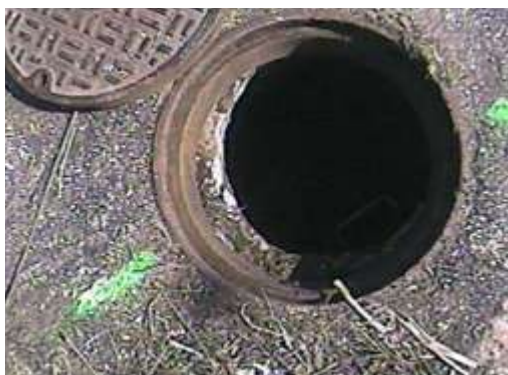
Defect 2

**Frame** Offset: **2** (in.) Condition: ☒ Sound ☐ Cracked ☐ Leaks

frame offset

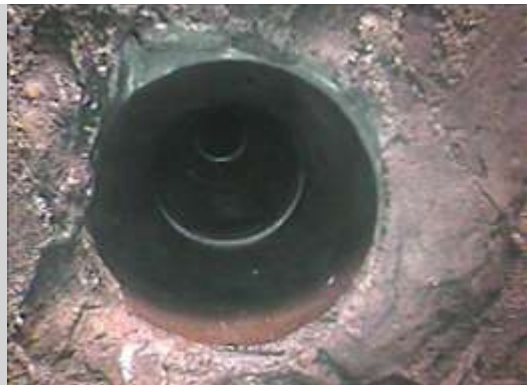
3 O'Clock Outflow

8 in. Circular Gravity Sewer  
Pipe Out @ 3 O'Clock
